# Appendix B Photograph Log

Project: ACM Abatement

Site Name: ASA CERCLA 07-2013-008  
Carter Carburetor Superfund Site

Site Location: 2840 North Spring Avenue  
St. Louis, Missouri

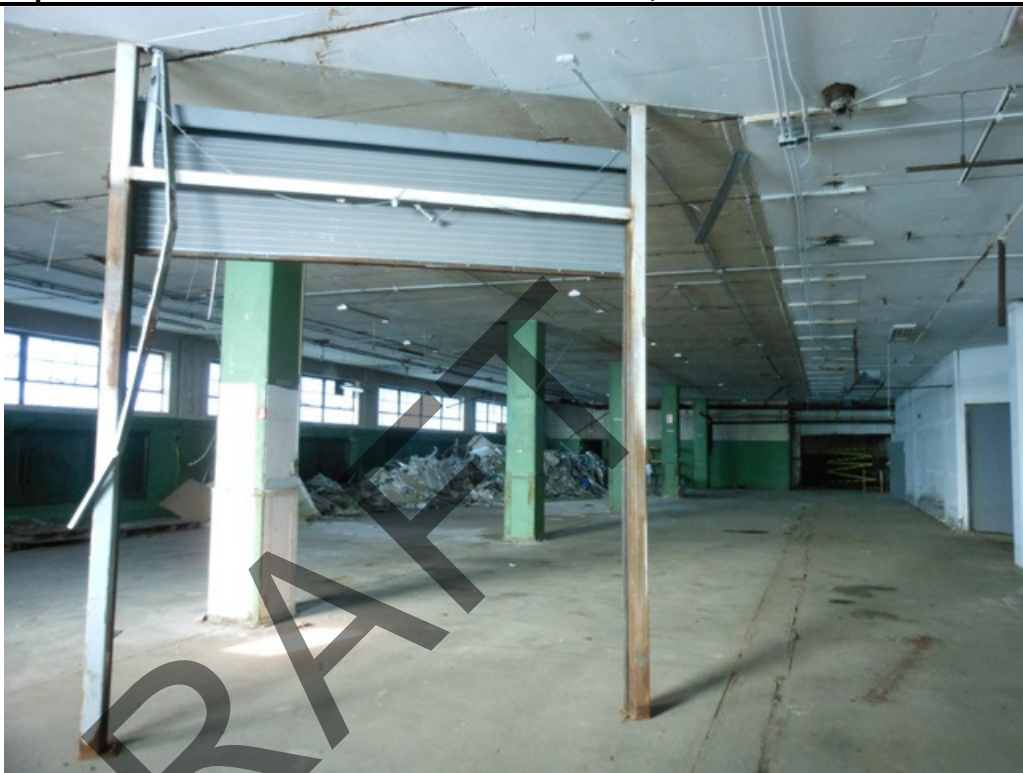
Location:  
1PP-18

Comments:  
P-5 – Willco Building Interior  
Building can be used for  
staging and storage.

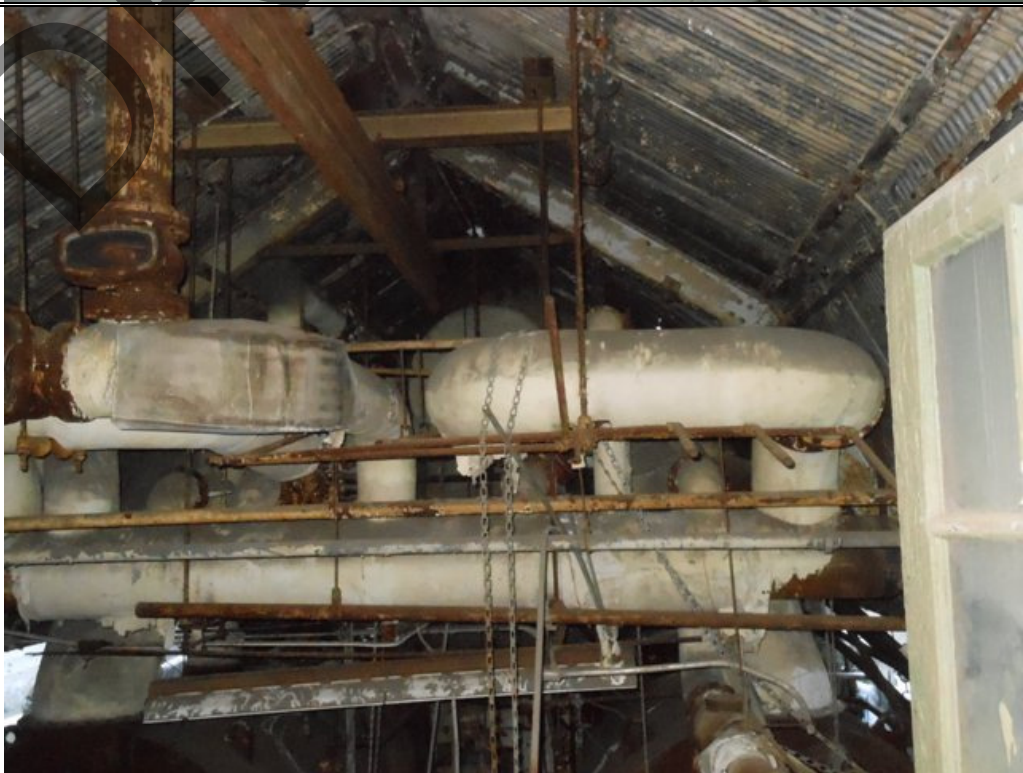
Location:  
1J-6

Comments:  
P-6 – Enclosed Boiler room  
with asbestos breeching.

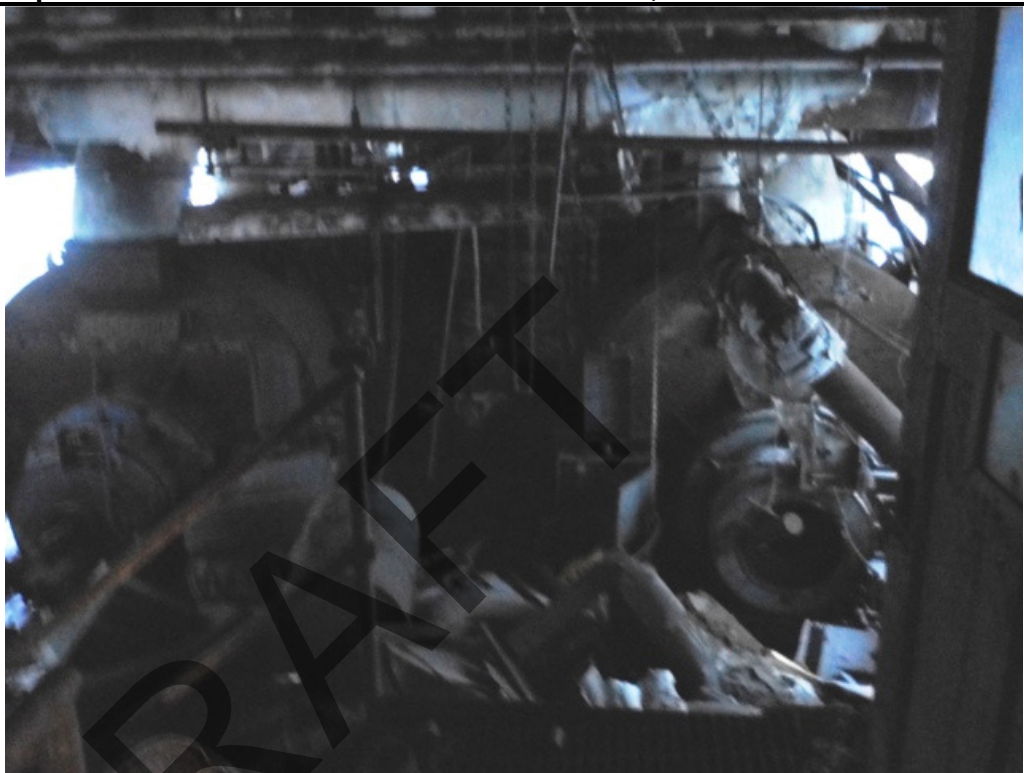
Location:  
1J 6

Comments:  
P-7 – Enclosed boiler room  
Remove asbestos  
contaminated equipment and  
debris to access asbestos  
Thermal system Insulation

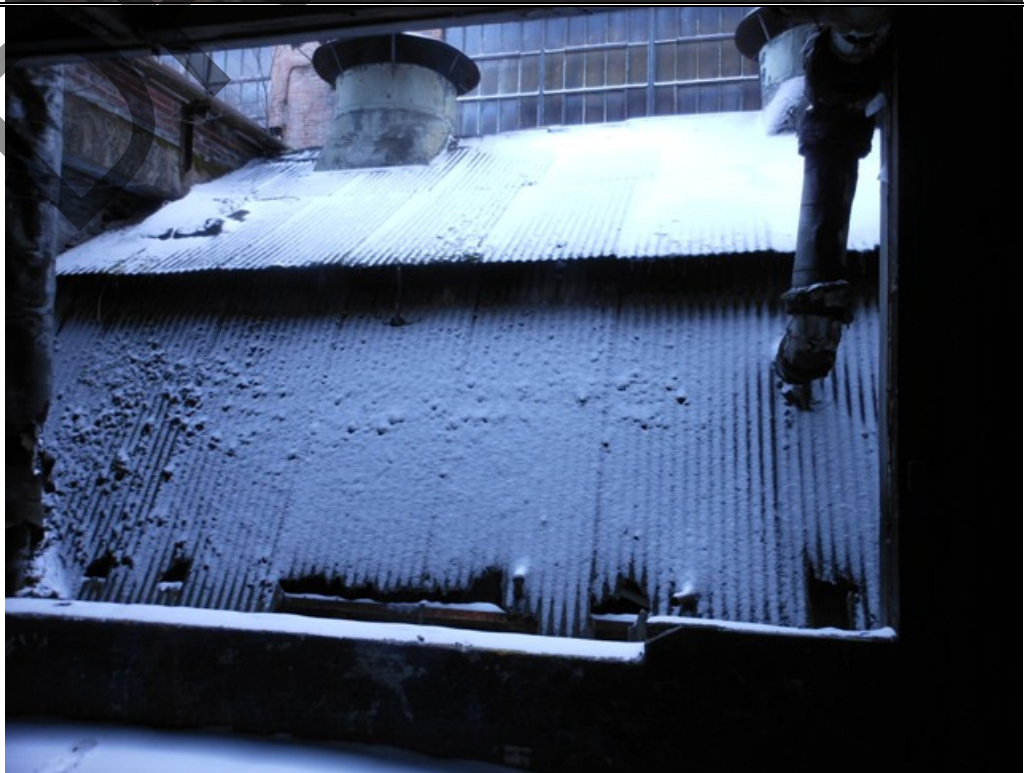
Location:  
2J 6

Comments:  
P-8- Boiler room is enclosed  
with Transite roof and wall  
panels.

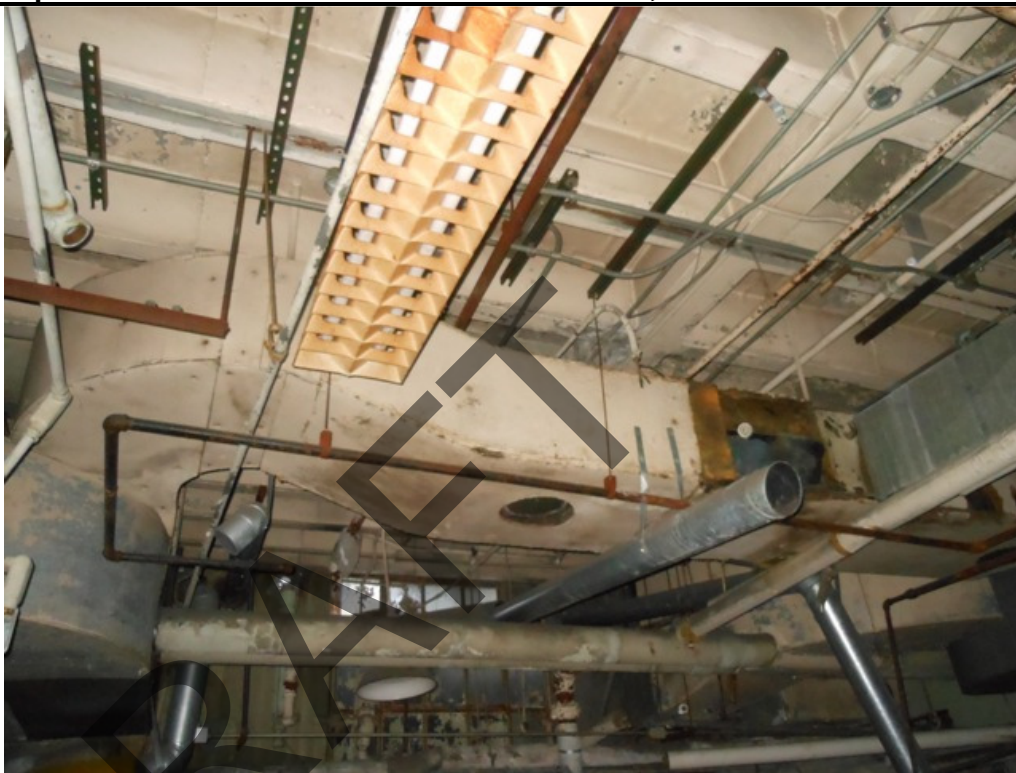
Location:  
Pump Room

Comments:  
P-9- Insulated duct and  
piping in pump room area

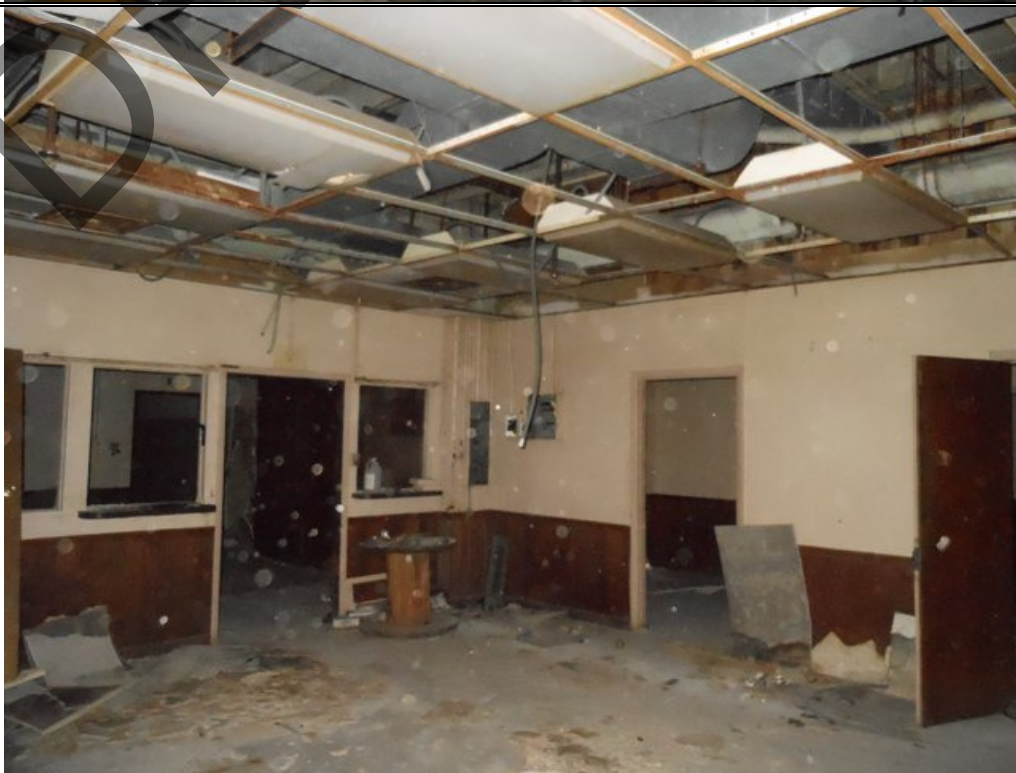
Location:  
1J1-1F4

Comments:  
P-10 – office area first floor

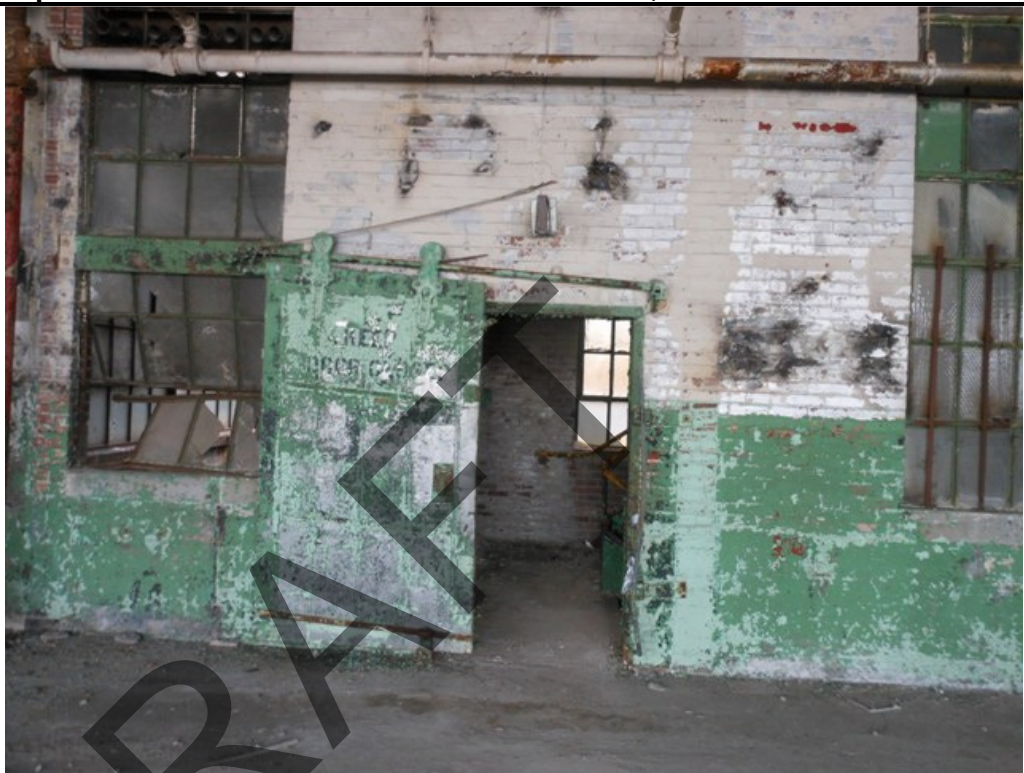
Location:  
Close-up

Comments:  
P-11 – Typical fire door  
installation

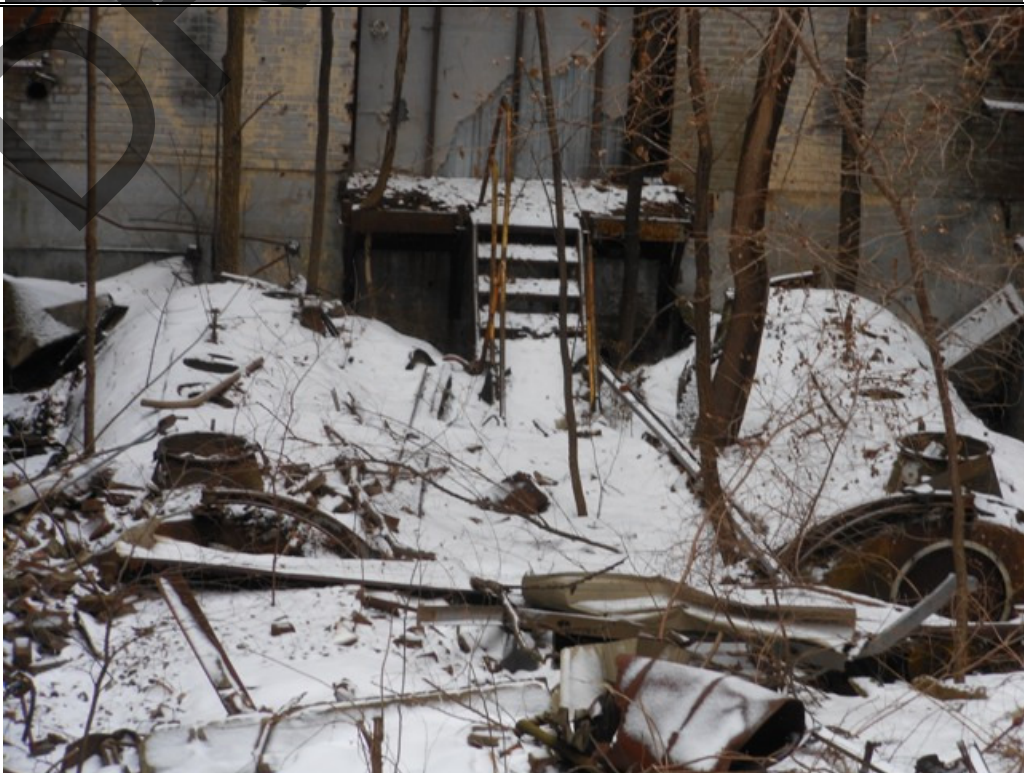
Location:  
Open Boiler Room, 1J 6

Comments:  
P-12 – "Open" Boiler Room  
Area is no longer enclosed.  
Remove asbestos insulation  
and asbestos-contaminated  
debris.

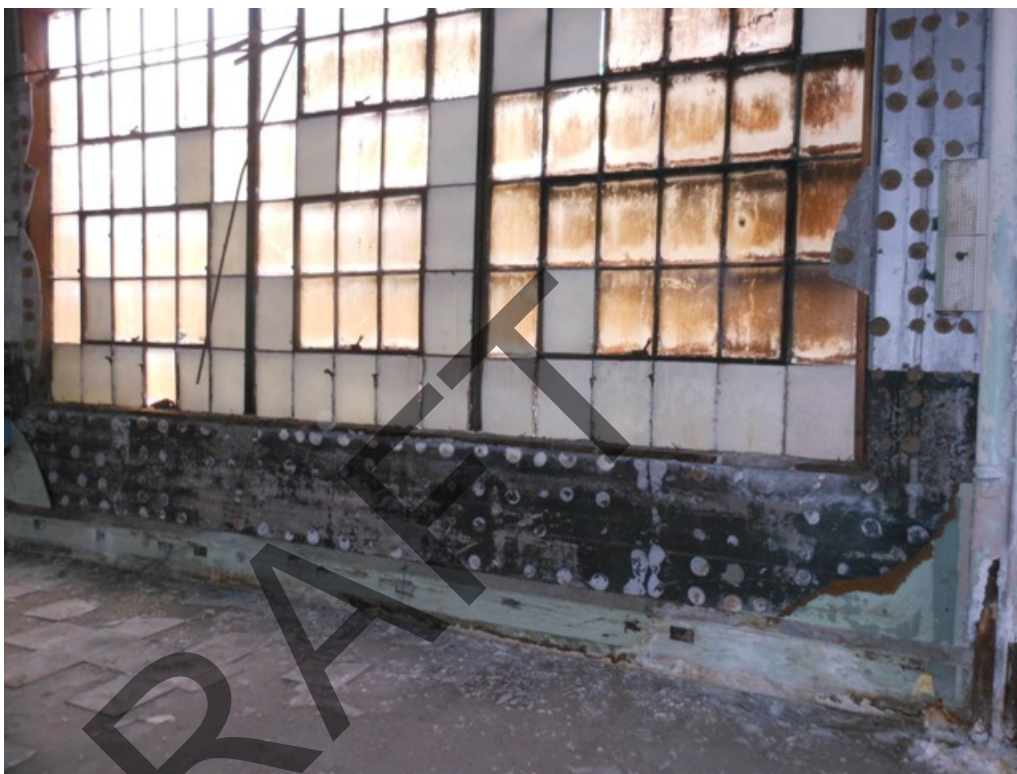
Location:  
2 B 7

**P-13** – Asbestos glue “pucks” behind ceiling tiles mounted to wall are similar to those on the ceilings. Floor tile and mastic also to be removed. Windows with asbestos glazing and putty are part of the building envelope.

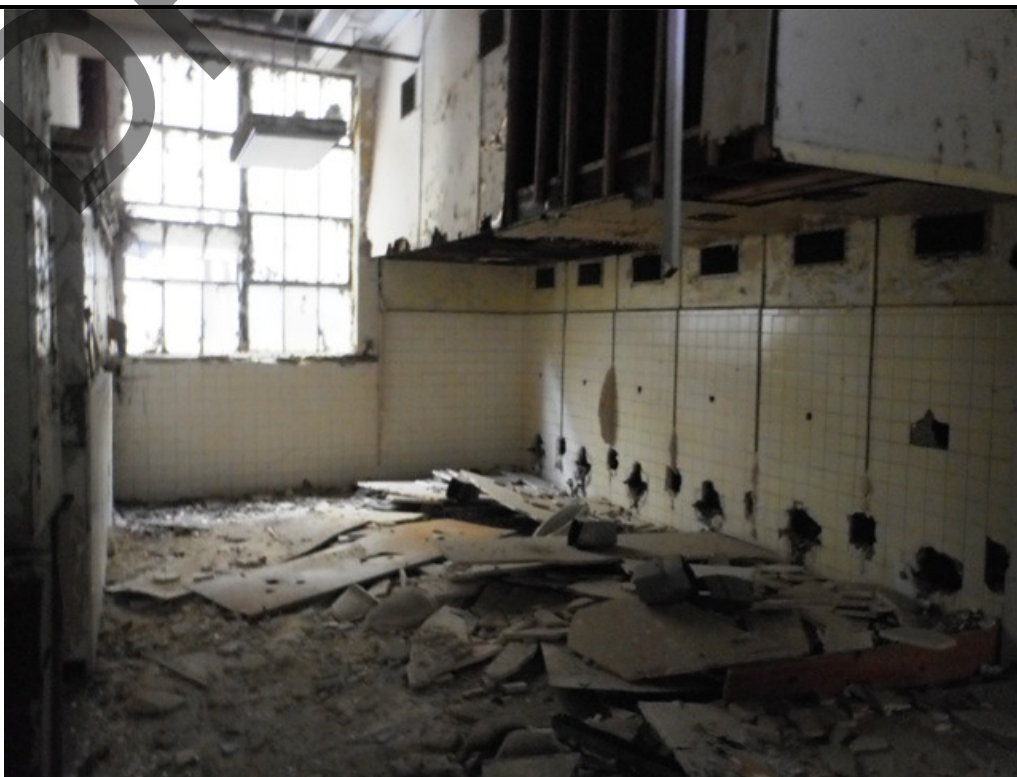
Location:  
2 F 5

**P-14** – Plumbing fixtures removed from restrooms. Floor debris must be removed to access floor tile and piping in chases.

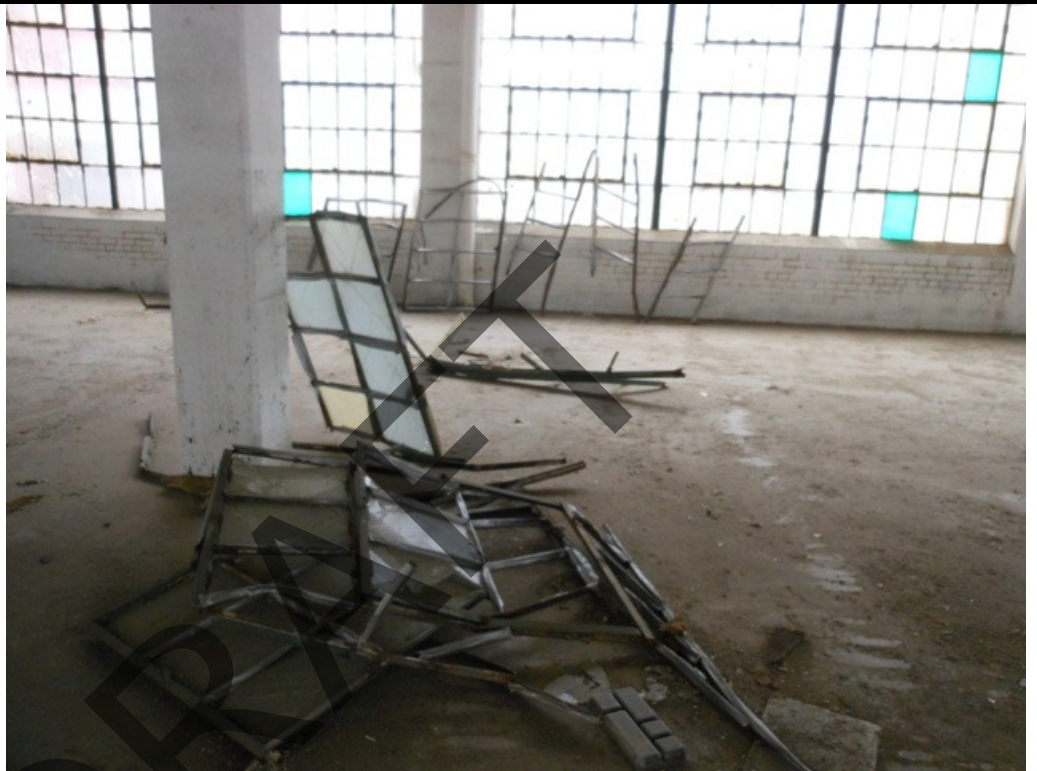
Location:  
3 GG 7

Comments:  
P-15 – Windows removed by others from load out locations are stockpiled in building. Window caulks and glazing putty is ACM.

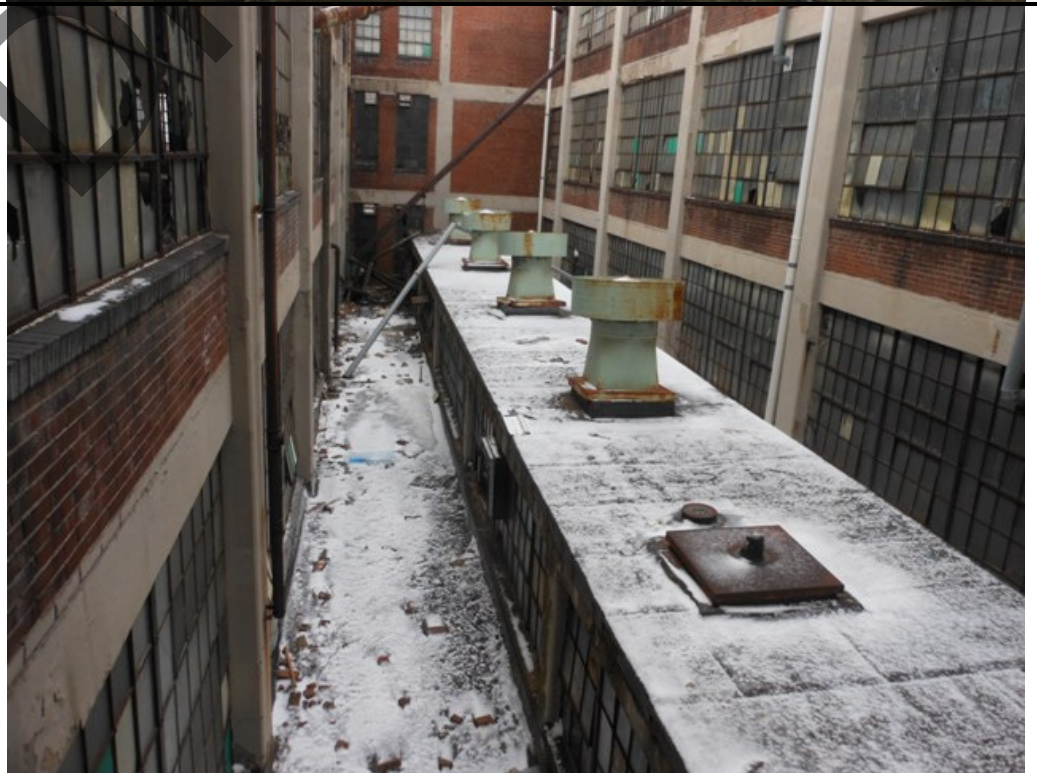
Location:  
2 NN 5

Comments:  
P-16 – Several open light wells have roofs and windows at lower elevations in the building.

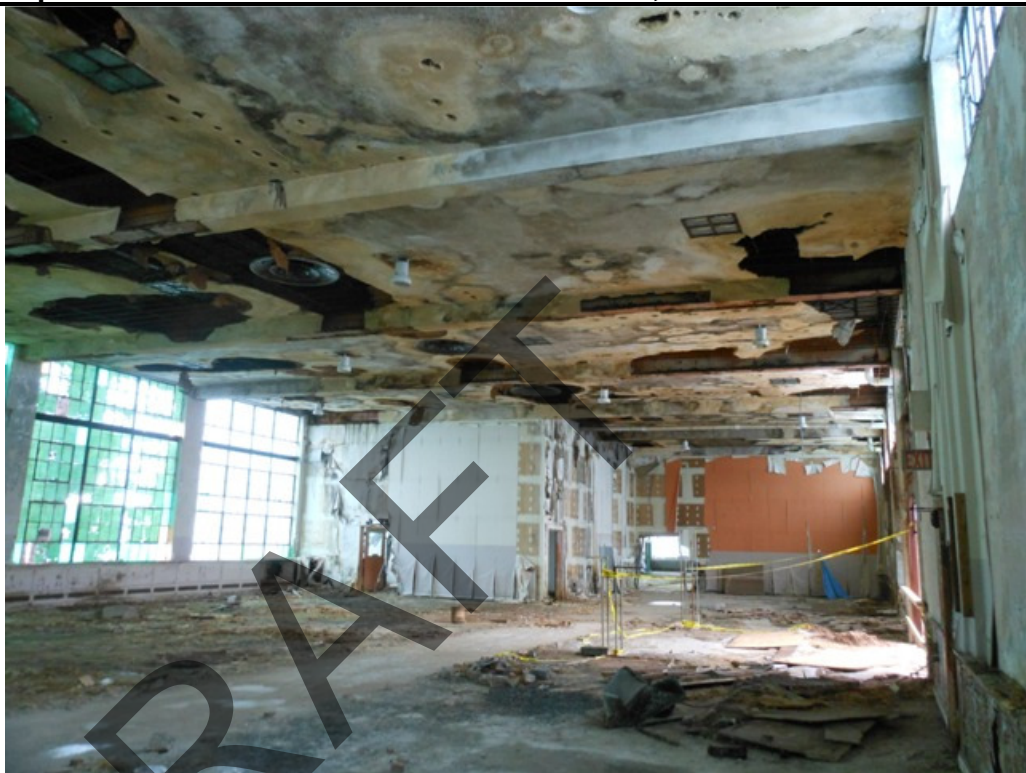
Location:  
4 HH 11, South

Comments:  
P-17 – Main cafeteria  
Asbestos plaster falling from  
ceiling has resulted in  
considerable asbestos debris  
on the floor.

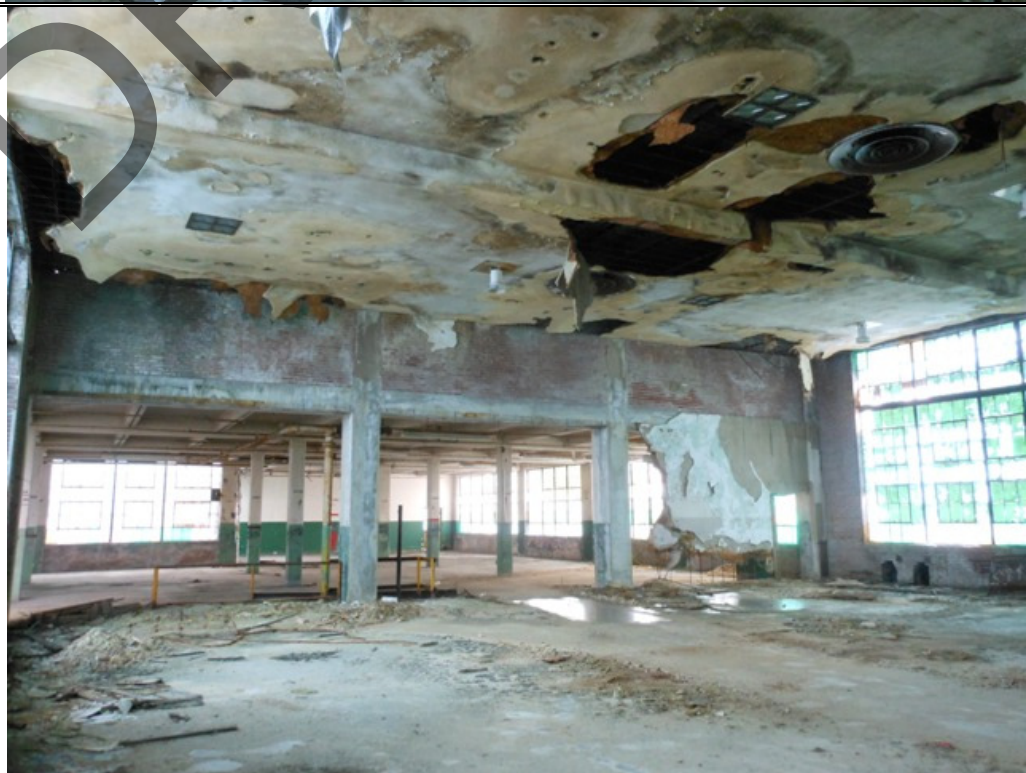
Location:  
4 HH 11, North

Comments:  
P-18- Damaged asbestos-  
ceiling plaster is hanging  
down.

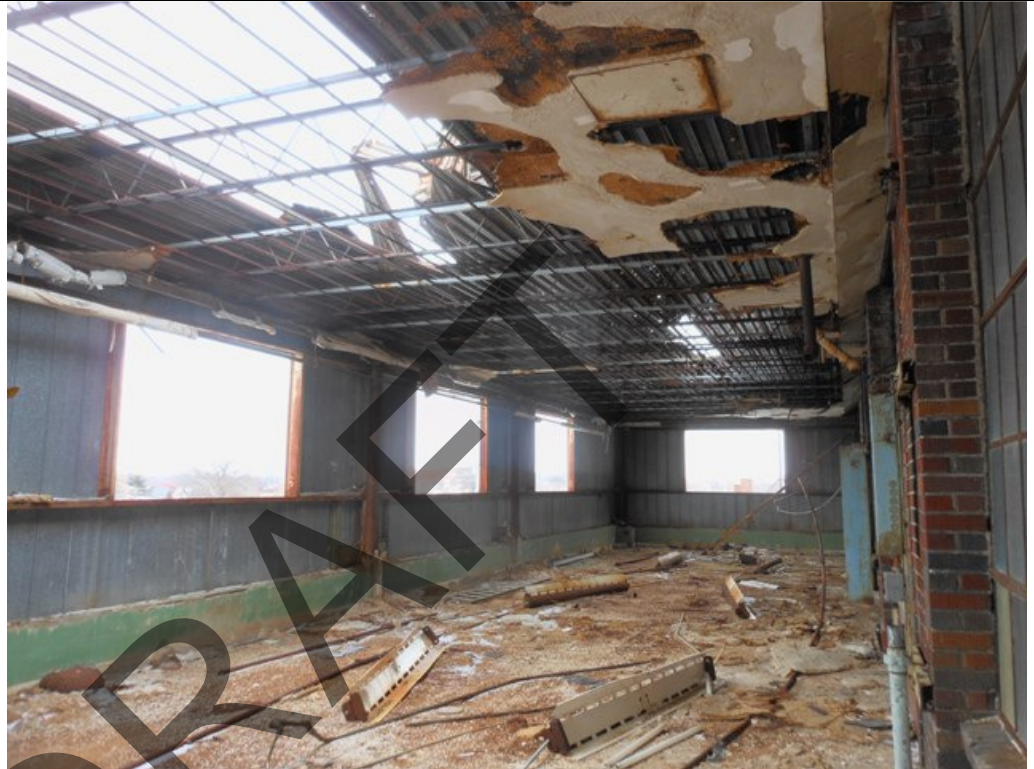
Location:  
4 BB 2

Comments:  
P-19 – Rooftop mechanical house. Equipment removed. Debris on floor is contaminated with asbestos ceiling plaster and TSI

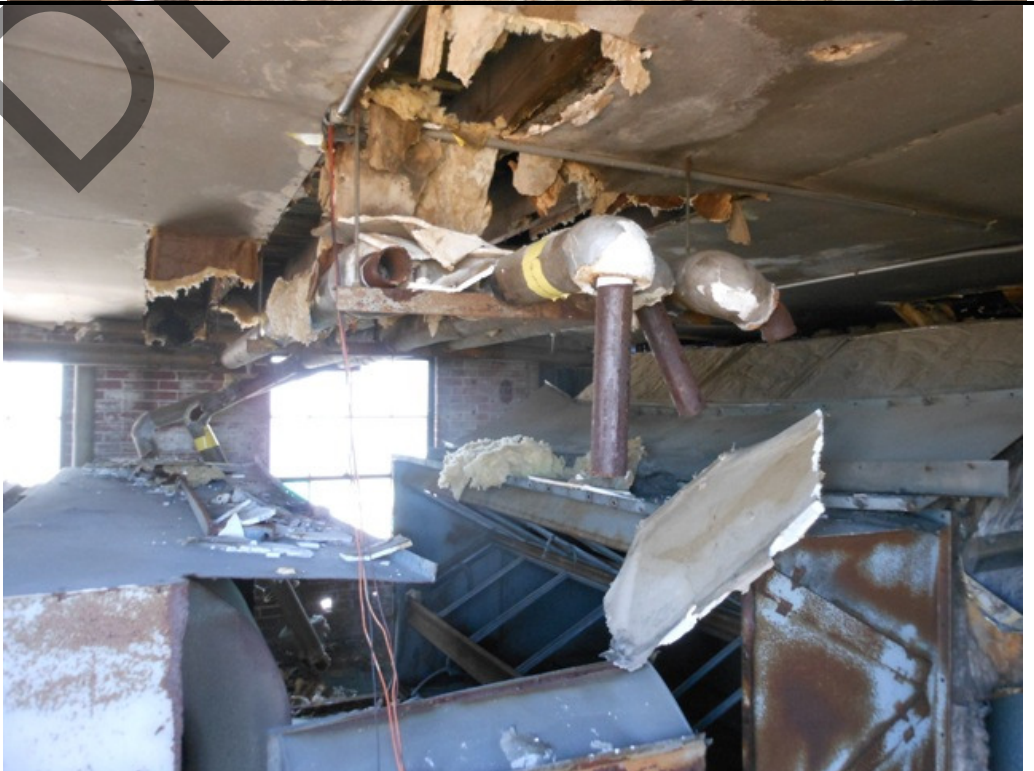
Location:  
R M 3, Rooftop House I

Comments:  
P-20- Asbestos insulation and hard joints is in poor condition. All debris and equipment is assumed contaminated.

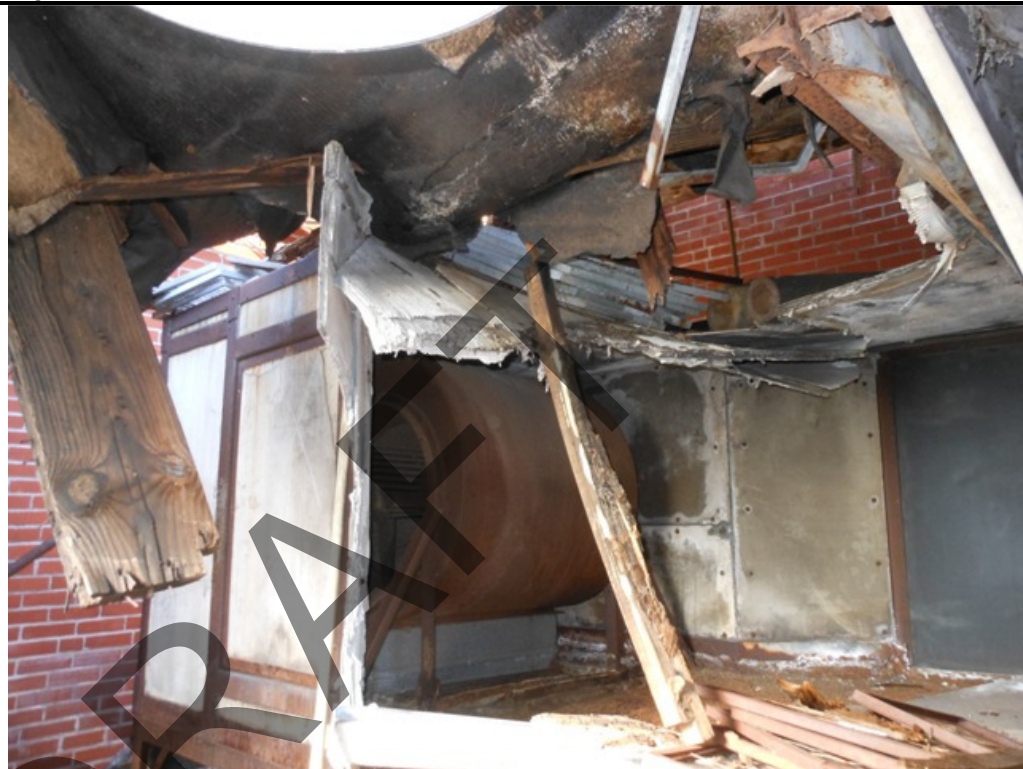
Location:  
R O 4, Rooftop House II

Comments:  
P-21 – Rooftop mechanical house. Insulation board on duct is layered Transite and AirOCeIl.

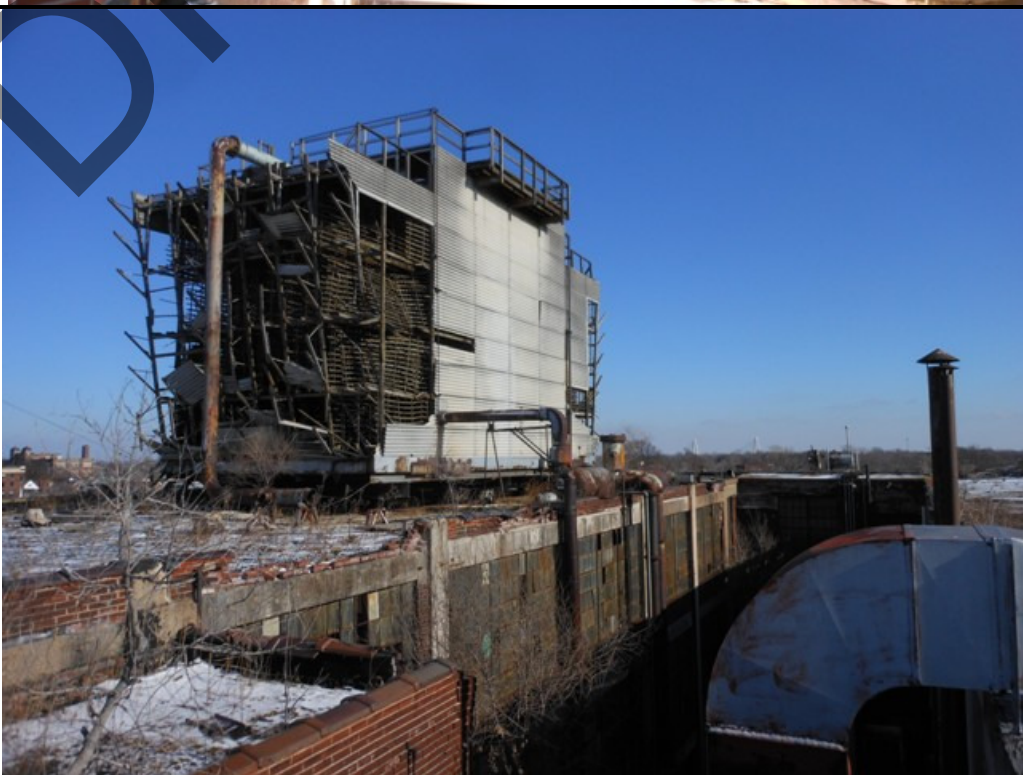
Location:  
CT-1

Comments:  
P-22- Main Cooling Tower has asbestos louvers and pipe insulation

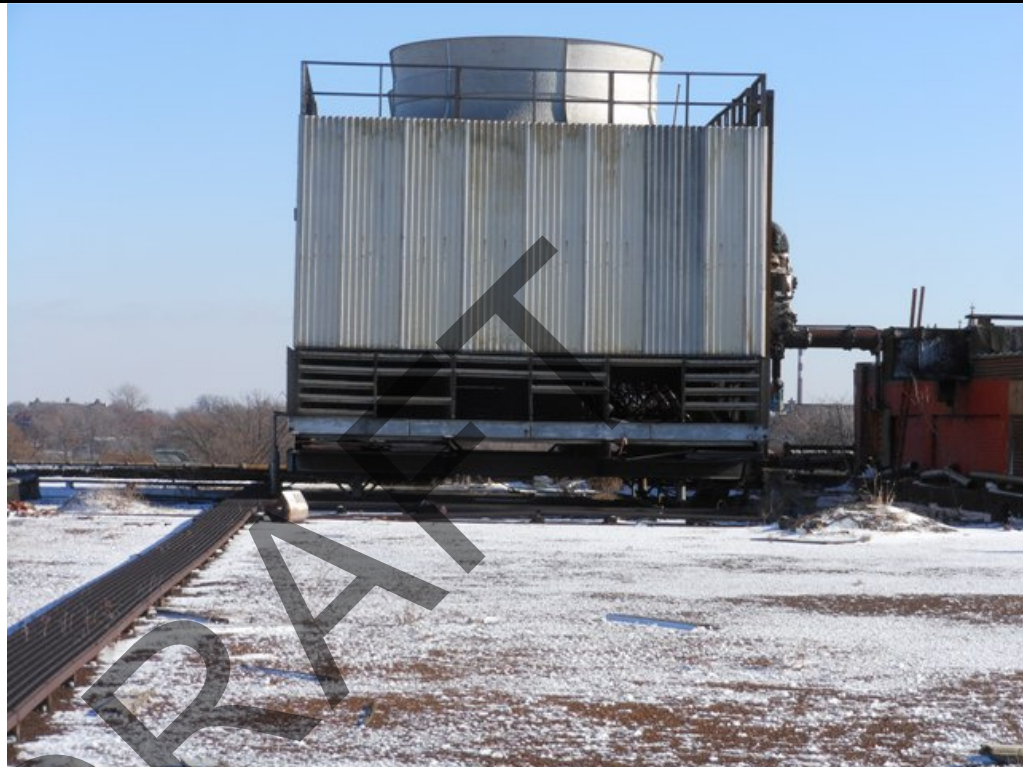
**Location:**  
CT-2

**Comments:**  
**P-23** –Cooling Tower 2 has  
asbestos louvers and pipe  
insulation

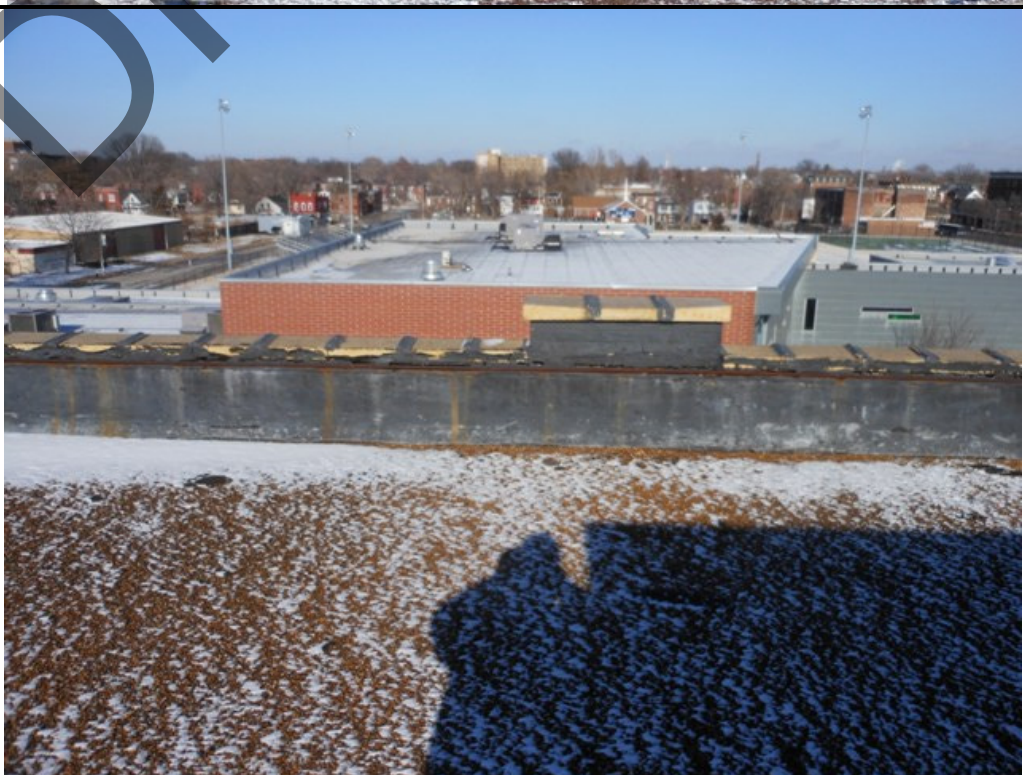
**Location:**  
R O 5

**Comments:**  
**P-24**- Roof capstones have  
asbestos cement on all of the  
joints. Flashing material and  
roof cements at parapet  
walls are ACM.

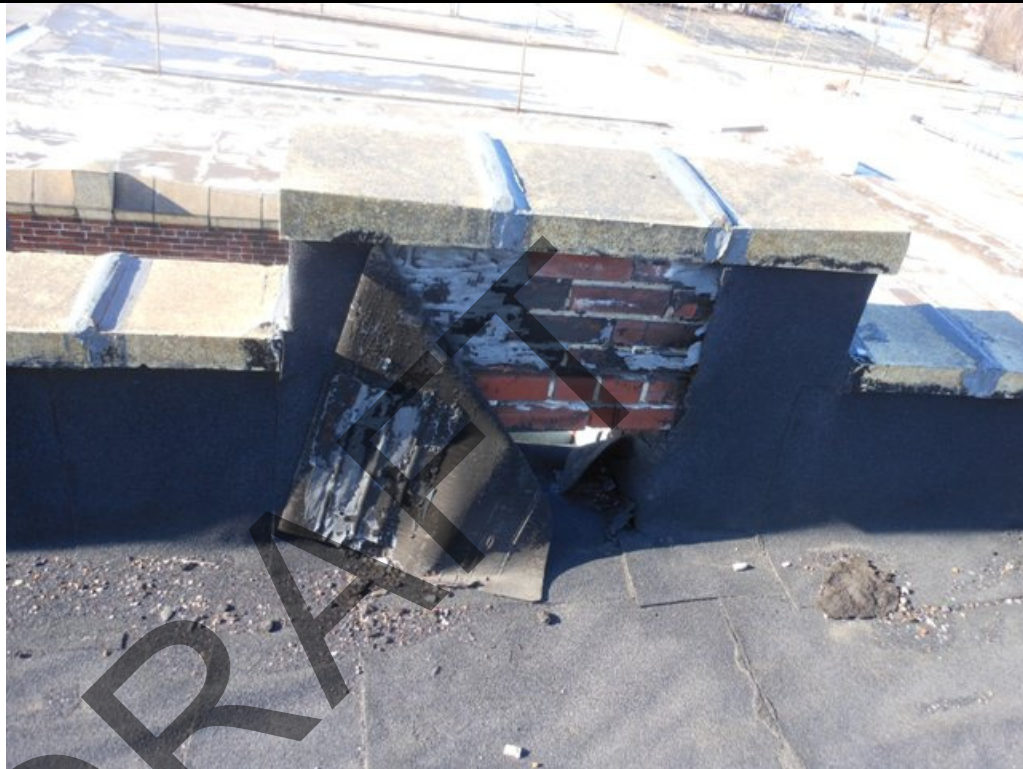
Location:  
R D 3

Comments:  
P-25 –Residual roof cements  
are present on parapet walls  
behind newer roof flashings.  
Assume this is typical of all  
roofs.

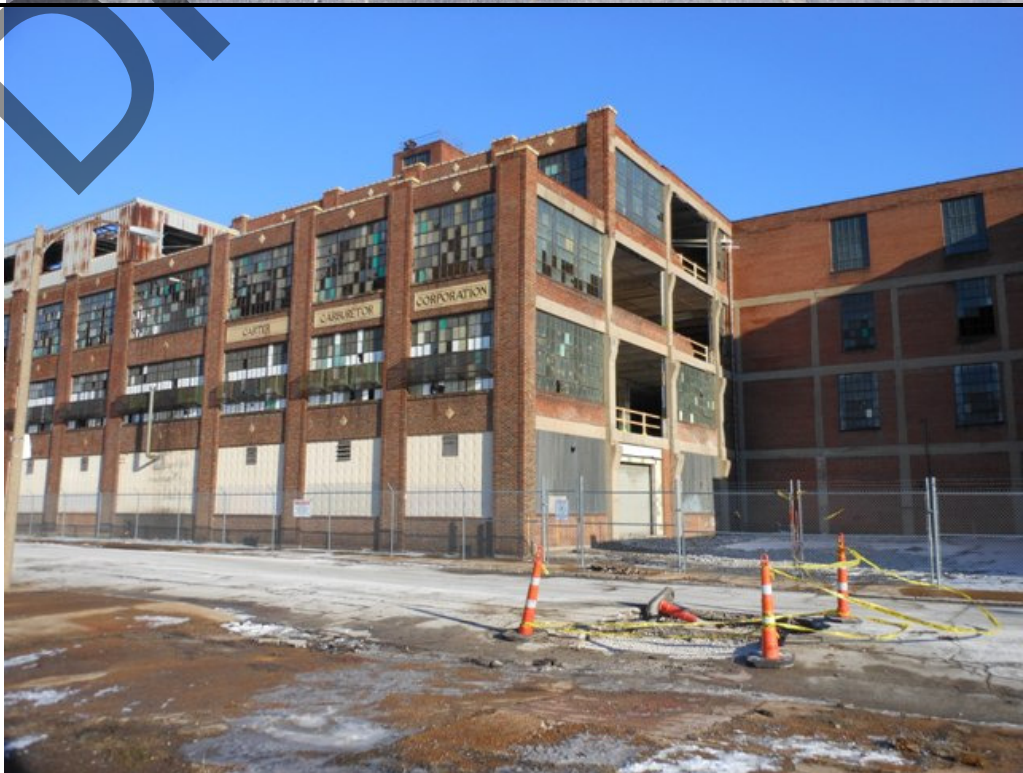
Location:  
Load Out

Comments:  
P-26- Load out area on  
spring street.
